ARCHITECTURE AND MOSAICS IN RECENTLY DISCOVERED PALAEOCHRISTIAN BASILICAS

MUSTAFA ŞAHİN

In this paper, the importance of Bursa and its surrounding area for understanding Early Christianity between the Late Roman and Early Byzantine periods, which we have very little knowledge about, is going to be explained. To indicate this potential, the Basilica in Derecik which was found by coincidence in the early 2000's and where we started an excavation and a restoration programme in cooperation with Lausanne University in Switzerland in 2007, is going to be substantially discussed.

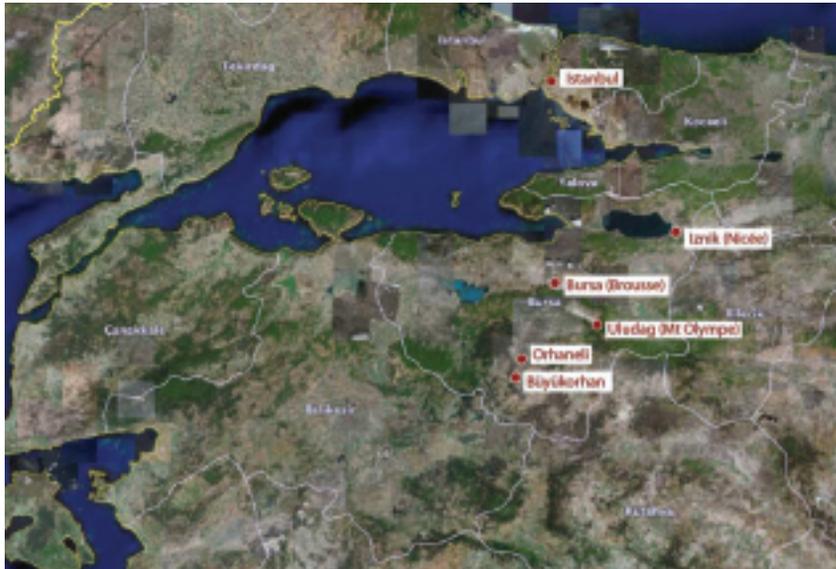
FIG.1

The Basilica in Derecik is located inside an oak forest in one of the settlements in Uludağ called Büyükorhan district (Fig.1). In March 2001, security forces went to that area with a suspicion of illegal excavation and found the Basilica by chance. The first excavation and research were done by the archaeologists Recep Okçu and Konca Hançer from the Archaeological Museum of Bursa. After the rescue excavation, which continued for approximately two months, a large part of the basilica with its mosaic floor was revealed. Later it was abandoned to its fate due to the lack of funding. The first publication about the Derecik Basilica was published five years later in the proceedings of the '3rd International Mosaic Symposium of Turkey'². The 3rd International Mosaic Symposium of Turkey also played an important role in the beginning of archaeological excavations and research around the Derecik Basilica: during an excursion to the site as part of the activities of the congress, Sophie Delbarre-Bärtschi and Claude-Alain Paratte from Switzerland had the opportunity of a close observation of the basilica and offered to complete the excavation and restoration with a cooperative project. After that, the excavations started again in 2007 under a protocol signed by all parties. The parties are the Institute of

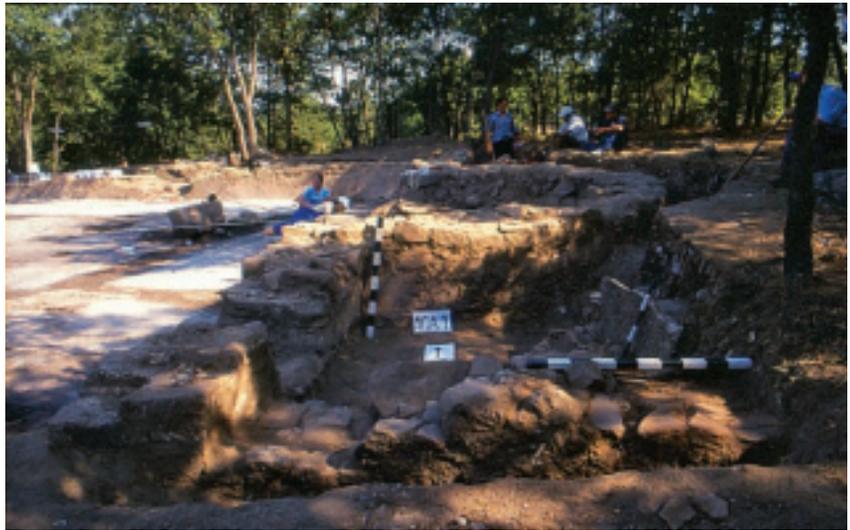
FIG.2 PHOTOGRAPH BY THE AUTHORS.

excavated area was then increased. The floor was covered by a mosaic pavement which was found by the probe. The excavations took place between 30.7.2001 and 20.8.2001. The structure was located just under the agricultural layer at a depth of 50-120 cm (Fig.2). After it was cleaned, it became apparent that the structure measured 12.5 x 20.75 meters. During the excavations, a church located in an east-west direction with nave, narthex, *presbyterium* and apse was revealed. The narthex has dimensions of 2.75 x 10.75 m and is 30 cm below the nave as a result of the slope of the terrain. The nave had dimensions of 10.30 x 10.75 m and was divided

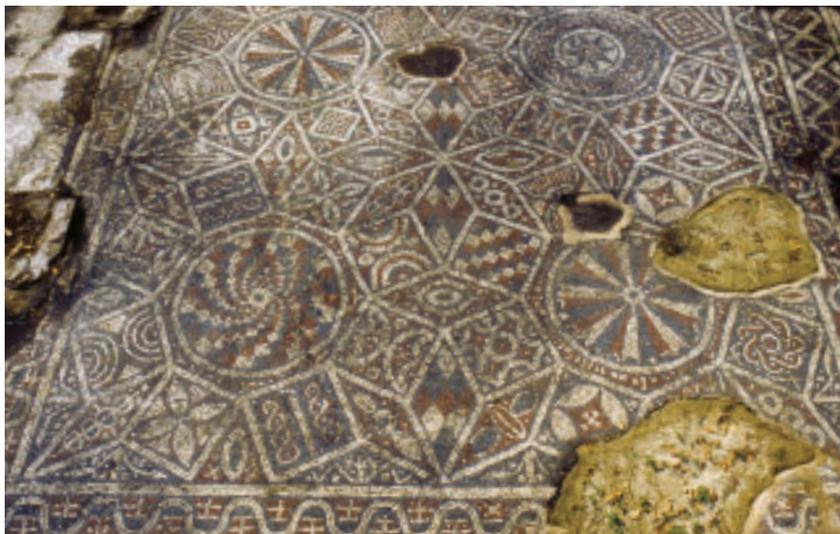
FIG.5 PHOTOGRAPH BY THE AUTHORS.

The floors of the narthex, nave and apse of the basilica were entirely covered by mosaics (Fig.5). The pavement was damaged in patches by tree roots and agricultural activities. It is ornamented with plant and geometric motives with rich polychrome frames. Together with those motives the figures of peacocks (Fig.6), partridges and pigeons can also be seen.

The mosaic of the basilica was laid in the *opus tessellatum* technique on a thick mortar foundation with white, red, yellow, olive green and dark blue tesserae. In the middle of the narthex mosaic is represented a *refrigerium* scene which has a mainly

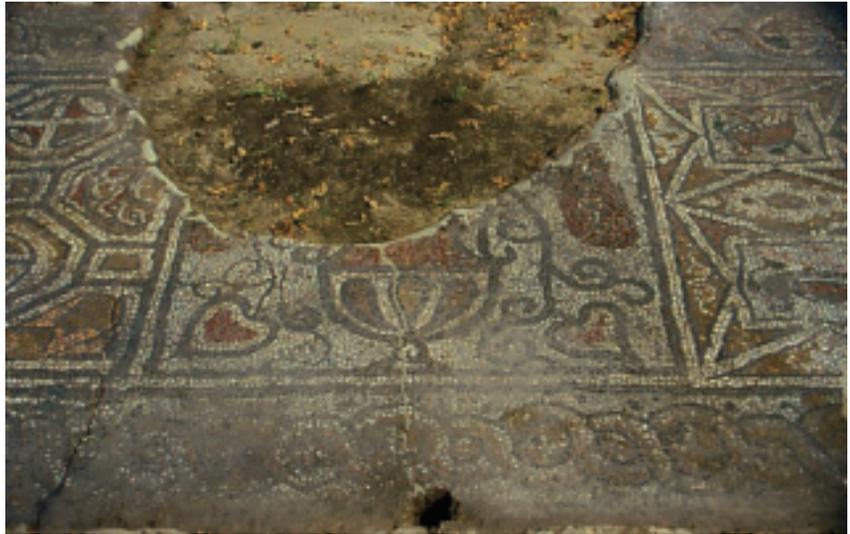
FIG.9 PHOTOGRAPH BY THE AUTHORS.

destroyed upper part and only a *kantharos* and two peacocks' tails were preserved in the lower part (Fig.9). Only geometric ornaments take part in the panel. The panel on the North side of the scene has only geometric ornaments, and the panel on the South is notable for its star motives containing stylized figures of birds (Fig.10). The mosaic in the centre of the nave is divided into two parts. In the first part there are figures of birds which are each drawn differently inside octagons with cross shaped transition components (Fig.5). Between them, guilloche and floral ornaments can be seen. In the other part, there is a three dimensional star motive in the centre with four circles around and surrounded by circles, squares and lozenge patterns. Every circle is ornamented differently: star, wheel of fortune, Solomon's knot, etc. In the area of the transition between the nave and apse, three heavily damaged inscriptions have been conserved each of three or four lines. The first epigraph indicates the wish of Epituchanos, *diakōn*, a church member; the other inscriptions have not been translated yet (Fig.11 e 12). Along the south wall of the nave, there is a band consisting of ivy with heart shaped leaves (Fig.13). In western section of the northern side, there is a composition' instead of 'setting starting with a peacock figure inside a rich interlacing. South of this composition, there are three medallions next to each other. The central one stands out with a *kantharos* figure and the other ones have stylized pigeon figures. In the northern side of the nave, there are two different significant compositions continuing through to the east (Fig.14). While a very rich interlaced composition lies next to the wall, adjacent to it is a composition filled with different geometric motives which consists of hexagons and octagons related to each other. In the *presbyterium* part, a panel represents heart shaped ivy leaves and two plait lines. Between these two plait lines, squares and circles are differently ornamented (Fig.15 e 16). In the *presbyterium* part there is a panel with a border of heart-shaped

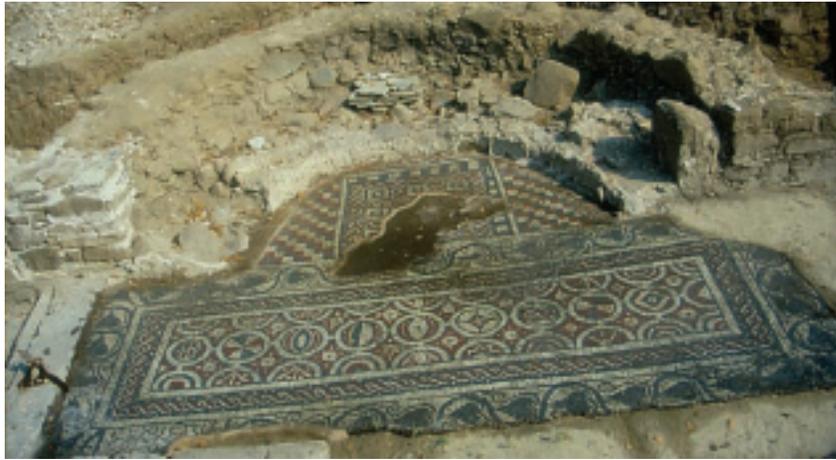
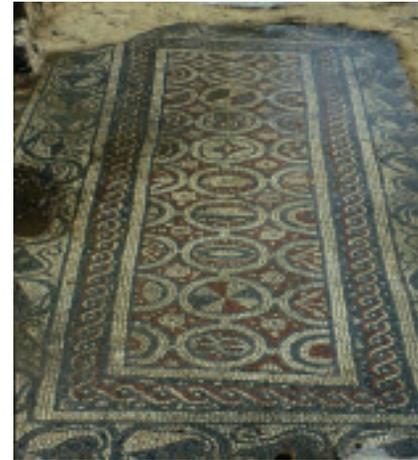
FIG.15 PHOTOGRAPH BY THE AUTHORS.

leaves and an inner border of two-strand guilloche. The panel is ornamented with a variety of circles and concave-sided squares.

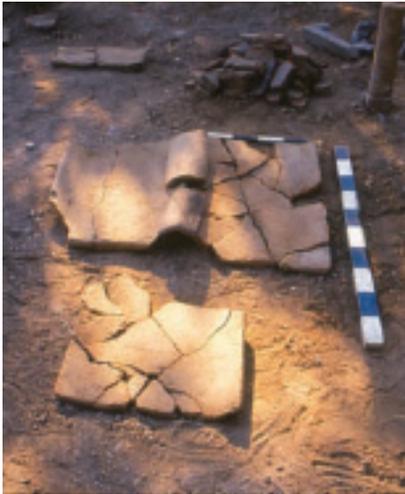
FIG.18 PHOTOGRAPH BY THE AUTHORS.

Marks on the wall indicate that there was fresco painting on the plaster. This is also indicated by numerous pieces of wall plaster found in the excavations (Fig.18). Furthermore, because pieces of tile were discovered within the remains, it demonstrates that the structure was covered with roof tiles (Fig.19).

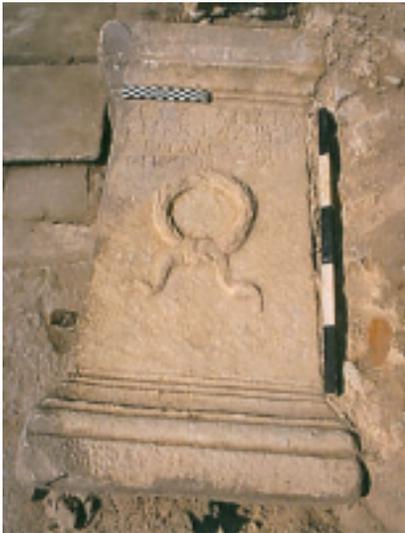
FIG.20 PHOTOGRAPH BY THE AUTHORS.

Two antique altars were used as backfill material (Fig.20). They were found during the rescue excavations in 2001 and show us that the basilica was not built here by coincidence. Each monument has an epigraph. On the marble altar used as a building material in the northern corner of the apse, we can read four lines. The translation of this epigraph is: "Zeus Anabatenos erected this monument for Zeus Kersoullos". According to this, we can say that Zeus was worshipped here under two different epithets. The second altar was found during the probe made inside the basilica. Zeus Anabatenos is also mentioned upon it. Based on these two artefacts it is possible to

suggest that the Zeus cult was common in or around this region. But nothing was found to support this suggestion during the excavations of 2007; in 2008, robbed-out walls under and in another direction as the basilica strongly indicate an ancient building. It does not seem possible that these altars have been brought here from a distant place for use in the base of the building because of their weight. It will certainly not be a surprise for us if we encounter a sacred area for Zeus around this site. This situation as we mentioned before will be the greatest evidence that this mountain was respected by all religions from polytheist to monotheist religions. Among the many churches whose existence is presumed, the Derecik Basilica is the first example which has been researched archaeologically. Therefore it is a great opportunity to bring the richness of the region's religious buildings erected in the Late Roman and Early Byzantine Age – its value as 'Olympos' – to the scientific world. The basilica indicates that Uludağ had a very important function in the enlightenment of the Late Roman and Early Byzantine Age dated to the 4th-5th centuries. The research which is going to be carried out in this region will play an important part in understanding this very little known era. ●
